US Army Corps
of Engineers
Waterways Experiment
Station

Miscellaneous Paper CERC-93-5
July 1993

Monitoring of East Breakwater Rehabilitation at Cleveland Harbor, Ohio

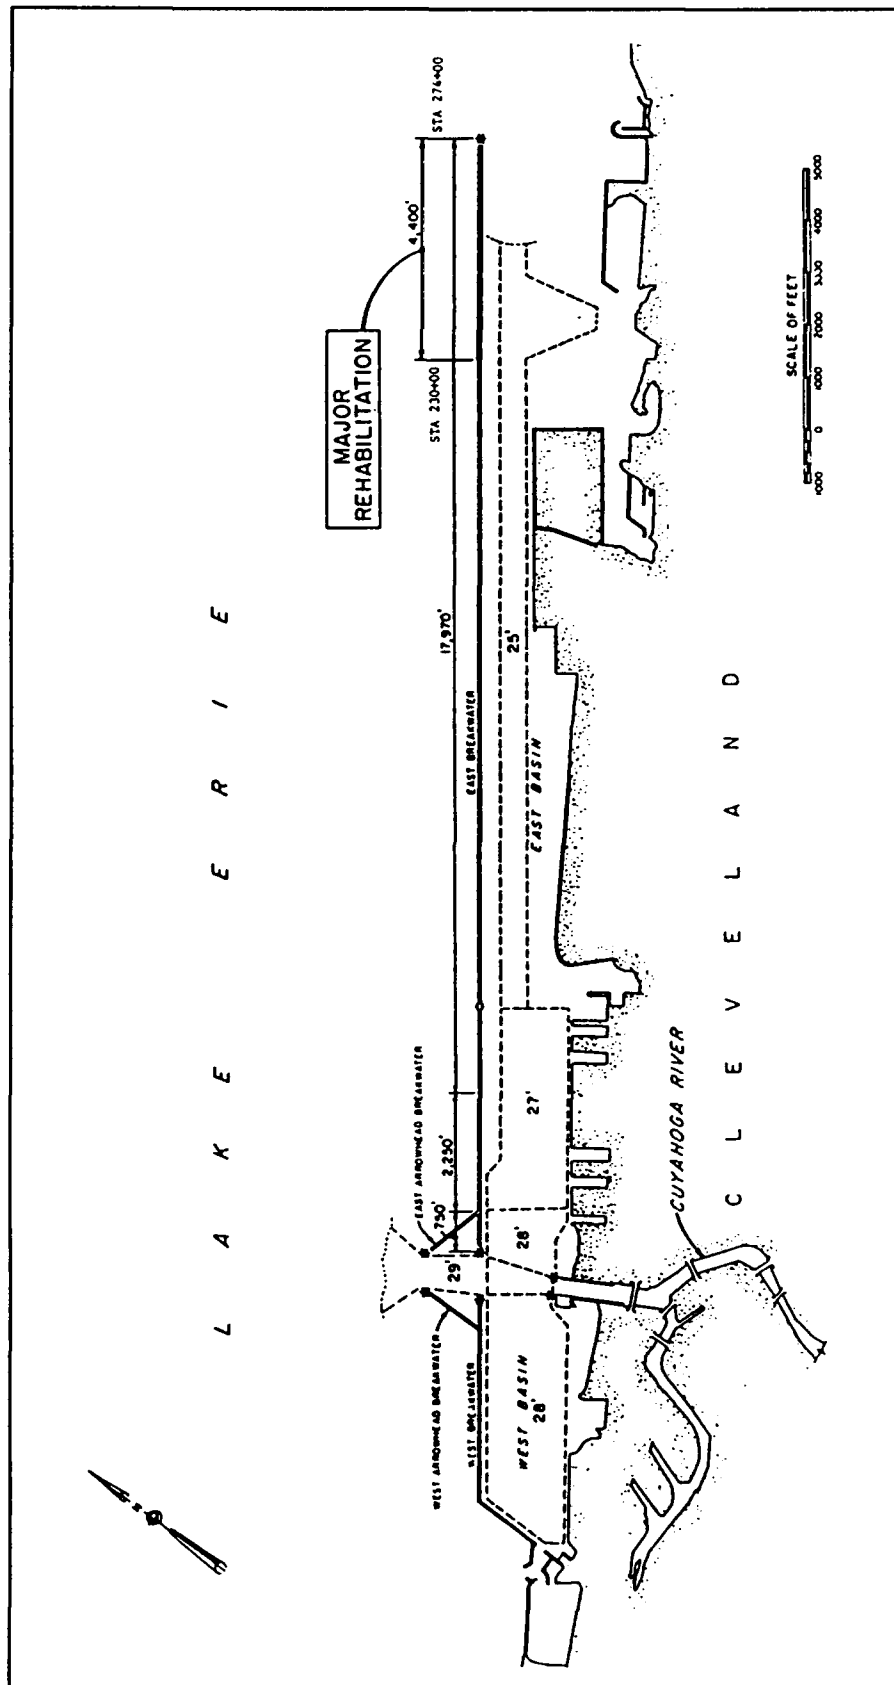
The pre-rehabilitated condition of the east breakwater varied between satisfactory and very poor. Portions of the structure were in such critical condition that the breakwater cross section had been breached at several sites and a major rehabilitation project was the only action that could bring the structure back to its design level of protection. Due to the advancing age of the east breakwater, progressive deterioration had reached a point where annual patchwork maintenance was no longer capable of retaining an effective section throughout the length of the structure.

Figure 6. Portion of east breakwater requiring major rehabilitation

A plan for major rehabilitation at the east end of the east breakwater (USAED, Buffalo 1979) consisted of repairing 4,400 ft of the structure (Figure 6) with concrete armor units (dolosse). Rehabilitation involved repair of the crest and lakeside of the breakwater trunk between stations 230+00 and 271+00 at a slope of 1V:2H. A slightly flatter slope (1V:2.5H) was designed at the breakwater head in order to use the same 2-ton units as cover protection throughout the length of the project and still maintain stability. A 100-ft-long slope transition zone was established between stations 271+00 and 272+00 (between the breakwater trunk and head). The repair of the breakwater head section started at station 272+00 on the lakeside and continued around to the channel side ending at station 272+00. The rehabilitation also included rebuilding the breakwater to its authorized project height (+10.3 ft).
